# JEEP HOSPITAL

Each month Dr Jeep (Tony Whitehead) takes us through the trials and tribulations at his "Jeep Hospital", USA 4X4 Jeep Specialist in Melbourne, Victoria. Over 20 Jeeps are admitted weekly for servicing and suspension work through to differential, transmission and engine rebuilds. Dr Jeep explains the diagnosis, the corrective surgery and future care of these vehicles.

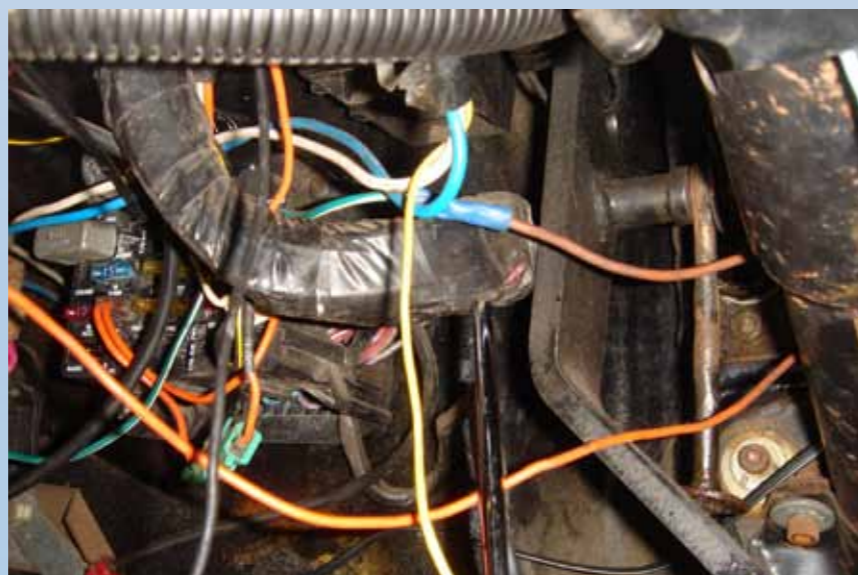
## BAD WIRING

This 1983 CJ7 has had a lot of different wiring jobs done under the dash, so it was rewire time. While I was under there I discovered the clutch lever just about to short out on a full size main power wire. Keeping an eye on wires contacting moving pedals under the dash is advised, especially after alarms, stereos and other accessories are fitted. This could have easily caught fire or cooked the main loom.

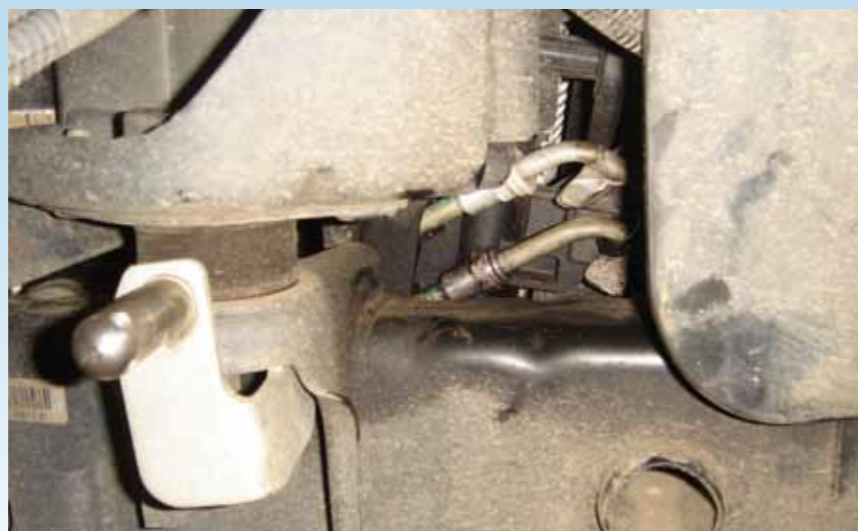
## OIL LEAK

This 2008 JK auto had been leaking around the front end of the Jeep. After a good look we found these alloy tube couplers and one was leaking there from the auto transmission to the auto fluid cooler in front of the radiator. One of the internal O-rings had perished, the part # 68003503AA, is available from Chrysler for a measly \$285 but if you had more time and less money I think you could source a replacement O-ring to suit. Either way both tubes come off using the appropriate pipe spanners and the two new ones click back into position like Lego and your leaks are over for now. One good thing, it won't leak much ATF either when removed.

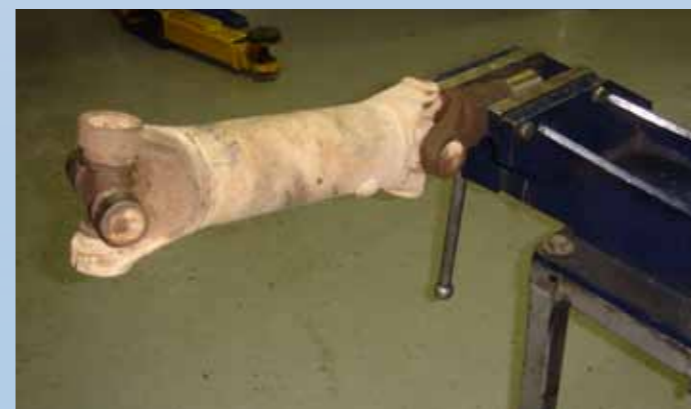
## SEIZED UNIVERSAL

Usually when inspecting for drive line vibration you would be looking for a universal joint with worn needle bearings. Sometimes a universal can go the other way and seize up solid. This one on a TJ tail shaft was found when trying to adjust the drum brakes. Rotating the rear wheels at full droop didn't feel right and on further investigation we found the rock solid universal joint. The photo shows the tail shaft held in the vice, it should be hanging downwards but the solid universal is holding it straight out. Two new universals and the TJ tail shaft was working correctly.

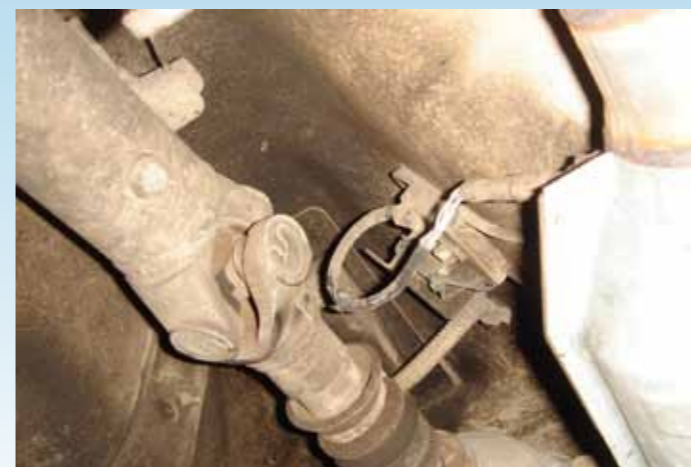
## XJ WITH A COUGH

An XJ with a cough and splutter eventually blew a fuse running the ASD (auto shut down) relay and stopped dead. Once replaced the Jeep would start and run but the scanner showed up a short on the down stream O2 sensor. There are usually two O2 sensors on anything pre 2005 and four on most rigs after that. This Jeep had a fresh looking catalytic converter fitted and a loose O2 wire that had rubbed itself through on the rear drive shaft. A new O2 sensor went in after re-tapping the threaded hole, then the code was cleared and presto, fixed. One thing to make sure you don't do when installing O2 sensors is to use any grease or chemical to lubricate the thread, it messes with the signal to the computer and will cause the Jeep trouble. If the thread is crook use a tap to repair it.

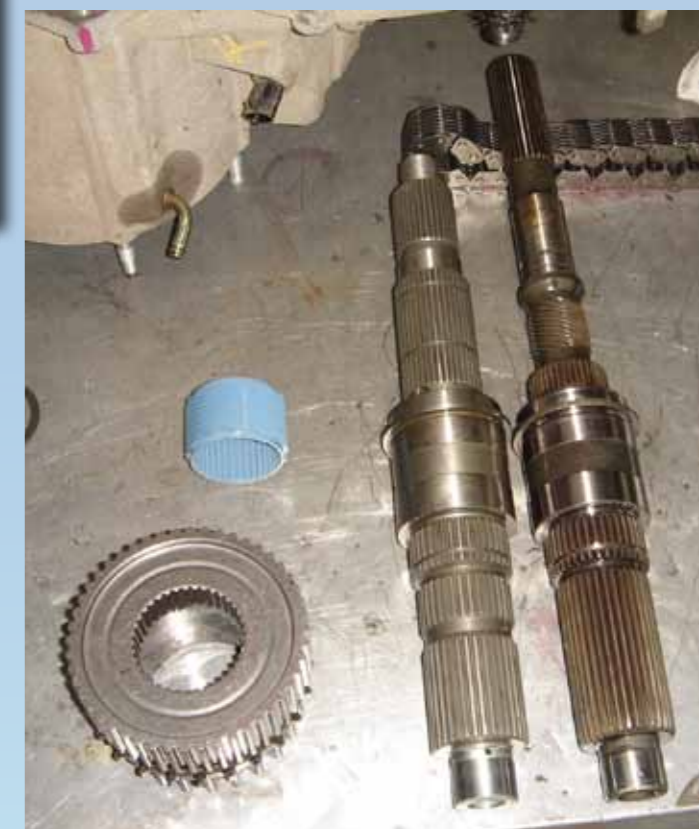
## SYE

One of the main reasons for upgrading to a SYE (Slip Yoke Eliminator) in a TJ is to alleviate drive line vibrations from a lift kit. It will also alleviate using a transfer case drop which loses precious ground clearance. The other reason is to strengthen the weak link in the drive line which is the speedo drive in the NP231 transfer case. When bigger tyres are fitted with standard gears this shaft can snap under load, and usually on a good hill climb. This results in front wheel drive only and sending you back down the hill in one form or another.

The blue spiral collar is the new drive compared to the steel spiral on the right.

The Teraflex SYE is typical of most SYEs and upgrades the speedo drive size to roughly twice the size and strength. You will need a new drive shaft as well. We use Teraflex or Tom Woods shafts and to finish the job a U-bolt style diff yoke is used.
