Each month Dr Jeep (Tony Whitehead) takes us through the trials and tribulations at his "Jeep Hospital", USA 4X4 Jeep Specialist in Melbourne, Victoria. Over 20 Jeeps are admitted weekly for servicing and suspension work through to differential, transmission and engine rebuilds. Dr Jeep explains the diagnosis, the corrective surgery and future care of these vehicles.

Jeep + Hospital

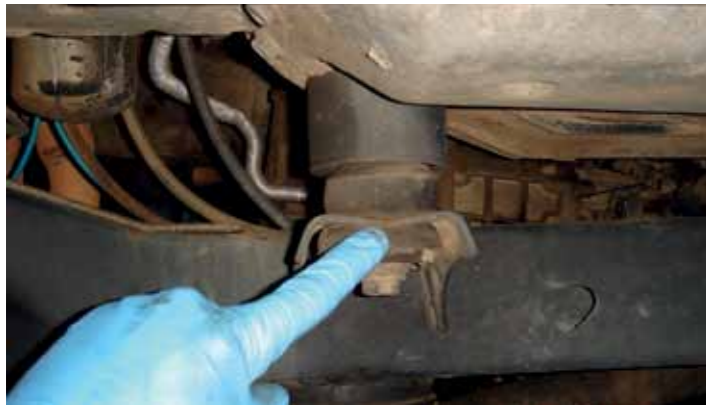
TJ FRONT BODY MOUNT

The front of the TJ body sits on this body mount each side just under the front foot well and this example has a two inch body lift spacer installed. Keep an eye on these chassis mounts, they tend to bow like this one until they crack through. This will give you an annoying constant squeak as well as not support the tub properly. We take the mount out and make up a custom plate to reinforce the mount and weld it back in, then refit the rubber and bolt it all back together.

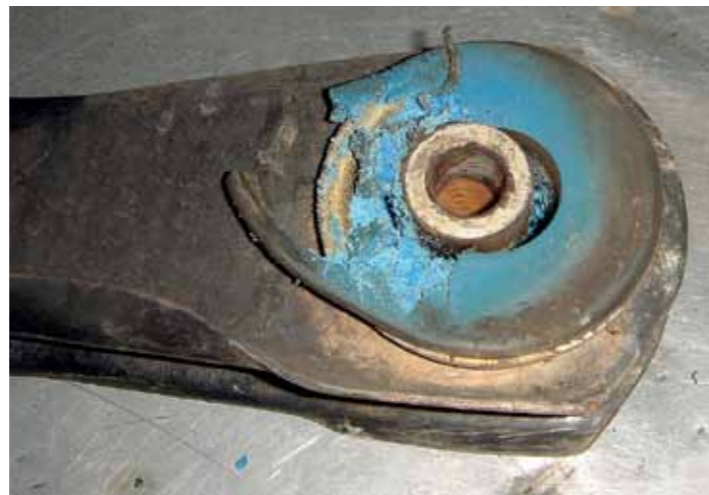
NYLON BUSHES

This was the front lower arm in a 2002 TJ. They are the same arm in all XJs, ZJs and TJs and had been refitted with a brand X blue nylon bush kit. As you can see this one is worn. I never use these unless it's the last thing I can get. Rubber bushes are so much better for less vibration transmission and longevity. Don't let any one talk you into these.

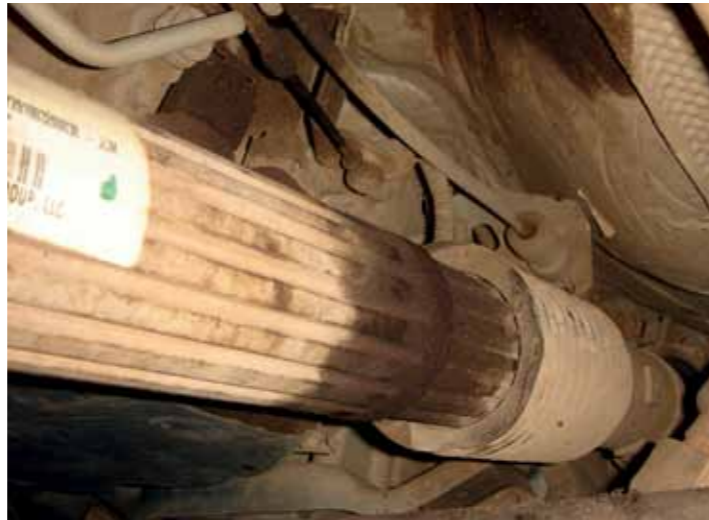
JK DRIVE SHAFT BOOT

We are seeing a lot of these lately. Front and back JK Wrangler drive shaft boots coming adrift one way or another. This allows mud and crud into the slipping tubes and wrecks your drive shaft. If you see your drive shaft boot not in its correct location, replace or repair it as soon as possible.

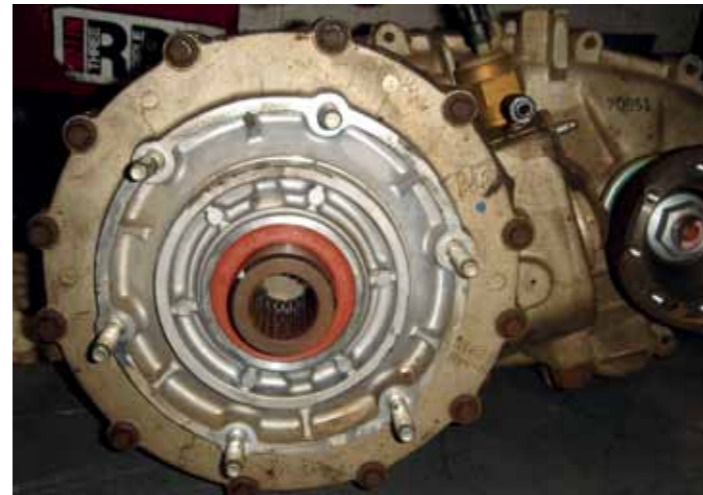
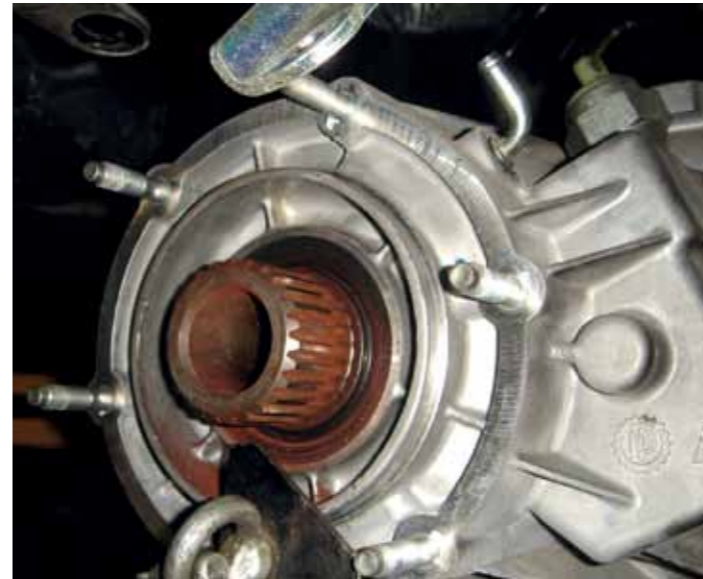
5 SPEED AUTO OUTLET

One of my plans hit a hiccup recently. We planned on swapping in a NV241R Rubicon transfer case with the 4:1 low range to the 2012 JK auto with the Pentastar. After pulling the standard 2.72:1 NV241 we discovered the new auto has a different output shaft, like a WG, the input shaft of the rocktrac was too small and we refitted it up and will see what we can do later to make it match. Watch this space.

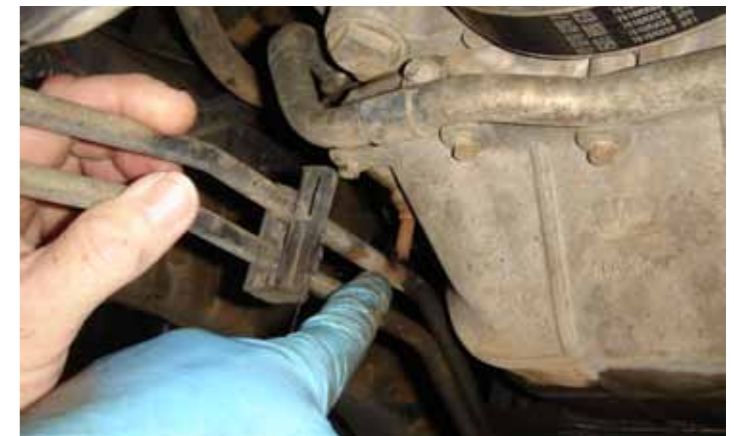
JK DIESEL LINES

This JK CRD had a pair of transmission lines running along the side of the sump, the little locator had come off and the lines were vibrating against the sump bolts. This was so close to wearing through but luckily we picked it up in a service while it was on the hoist. It got a few extra zippy ties and will live to see another day.

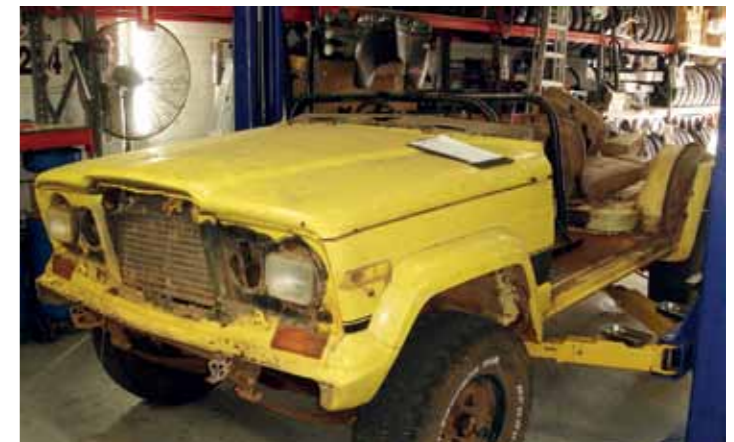
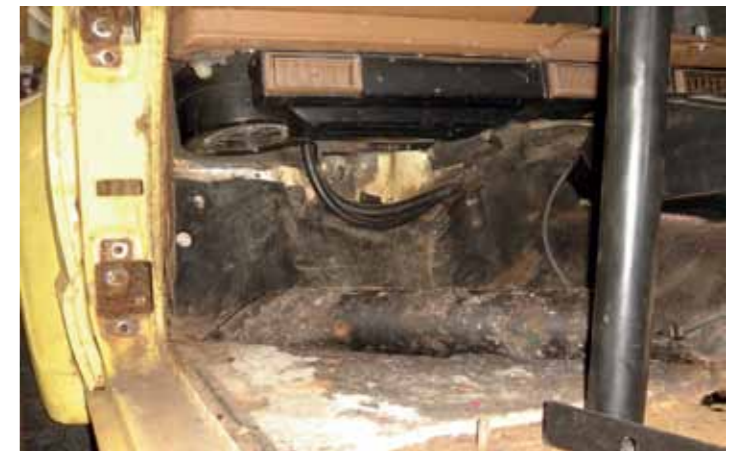
ASBESTOS JEEP

We're building up an old SJ Chief. It was so rusted that the body was removed and in that process we were taking the old rubber floor mats out and found this. Factory asbestos floor molded mats. They would have been installed in Toledo in 1977. If you have an old SJ or J Truck bear in mind you might have these mats too and drilling into them is a bad thing. We had to have them removed and disposed of properly before any more work. I guess they worked well and I learned a good way to ID asbestos in the process. Place a little on the end of a pocket knife and light it with a flame, if it burns it's AC sheet. If it doesn't burn and glows it's asbestos, so be careful and dispose of it properly.
