EARLY JK CLOCK SPRING HORN BUTTON REMOVAL

CLEAN ME!

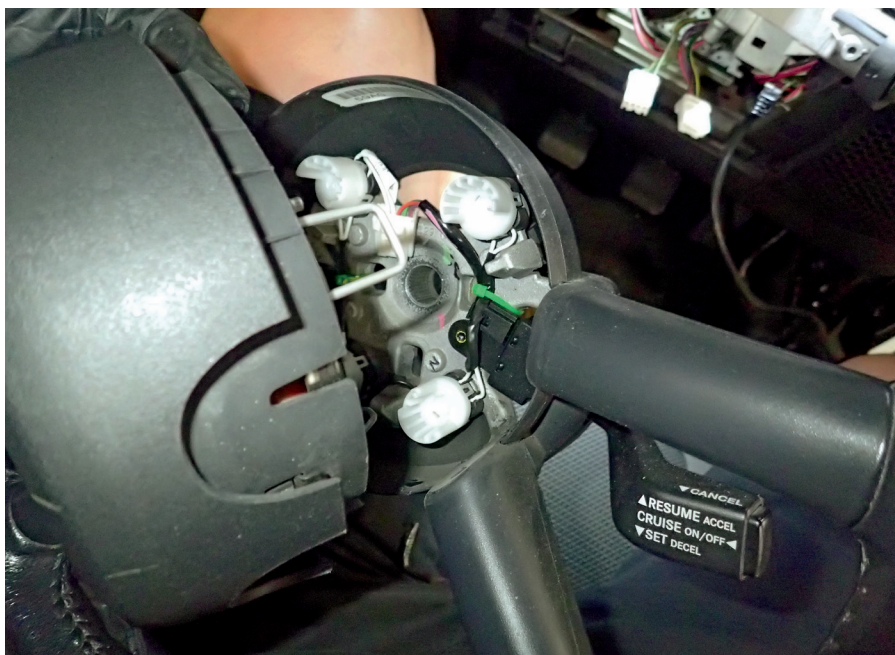
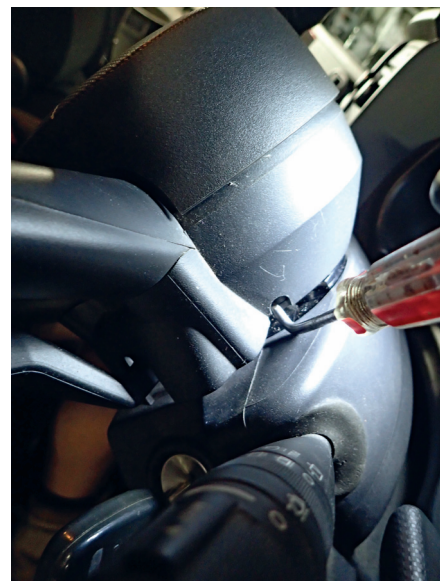
need to flick the three heavy wire prongs up to clear the locking tabs they all locate on, coming in from behind the wheel as pictured. Once one is unhooked the rest are still sticky, but at least this pic shows you where to shoot for.

button is off is straight forward – getting the horn button off is the tricky job. When you've disconnected the battery and waited 10 minutes you can make a tool up from a small flat bladed screw driver, you

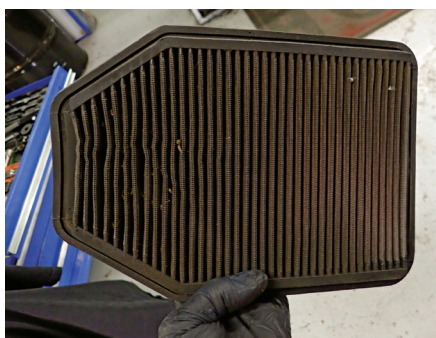
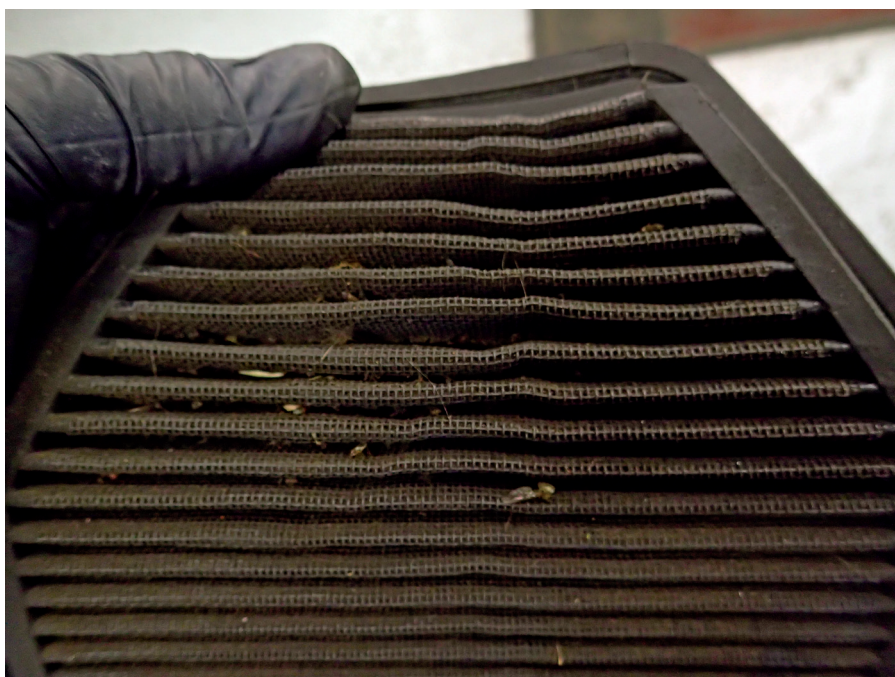
We had a JK in with a K&N filter. This one had been left to foul up badly. As it's not stock some dealerships won't touch it and this Jeep had been to a Jeep dealer for the last few services. They need to be cleaned each service and then some, especially if your running a snorkel as they suck in even more bugs and dirt than a stock set up does. K&N make a cleaner kit that we sell or is available anywhere. You need to shake out the main bugs, spray the cleaner on and hose it off with a medium pressure

hose, they come up like new before your eyes, then shake it dry, don't use compressed air as it can tear the cotton filament, then sit it in the sun to dry before re-oiling it. And don't over oil it either, too

much oil will block air flow and in some machines with carbies they will run rich with fuel and run like a dog. We now have K&N available for the petrol and CRD JK, available through us.
