JEEP HOSPITAL

Each month Dr Jeep (Tony Whitehead) takes us through the trials and tribulations at his “Jeep Hospital”, USA 4X4 Jeep Specialist in Melbourne, Victoria. Over 20 Jeeps are admitted weekly for servicing and suspension work through to differential, transmission and engine rebuilds. Dr Jeep explains the diagnosis, the corrective surgery and future care of these vehicles.

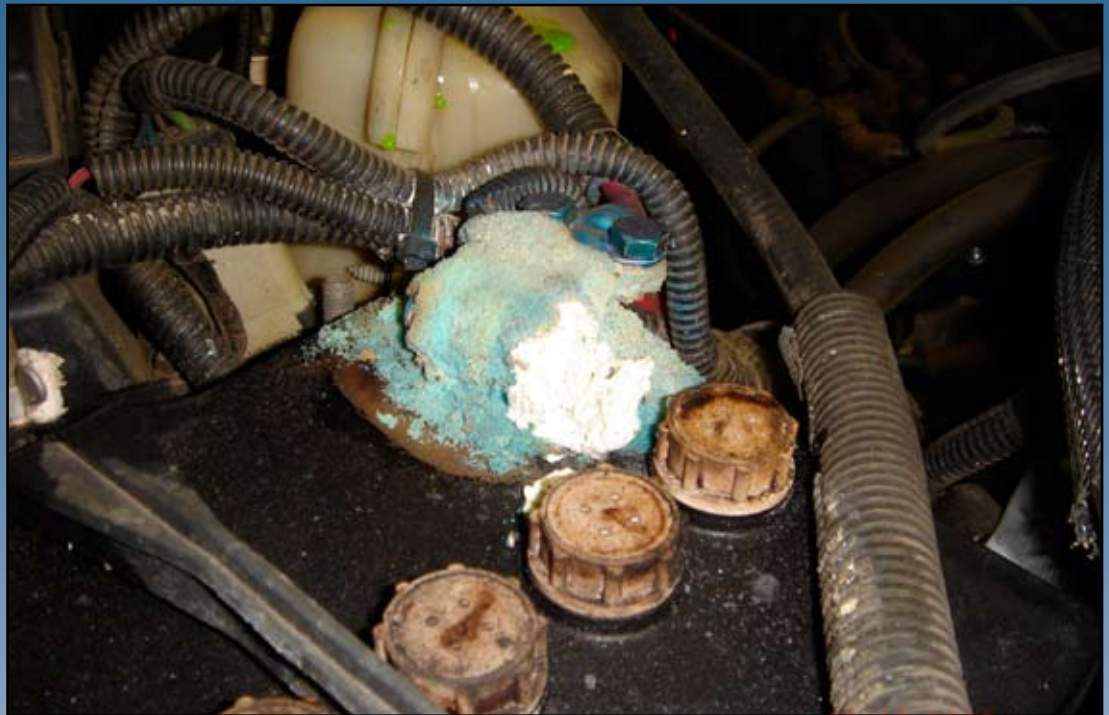
Badly corroded battery terminal

The first one is this second battery in an XJ not charging. Battery terminals need love too and letting one get to this state is bad form. To clean terminals in this condition, boil the jug and wash the battery down with the boiling water, somewhere outside where the run-off won't reach any storm water drains. Remove the terminal to check its still in one piece and clean with a wire brush. When you refit the terminal, spray some sort of battery terminal spray or grease on it so it doesn't happen again. While you're there, check the cells are all topped up – preferably with distilled water but cooled boiled water will do. I never have this problem in my Jeep though as I run a sealed Optima battery that won't leak acid and doesn't corrode like a typical battery.

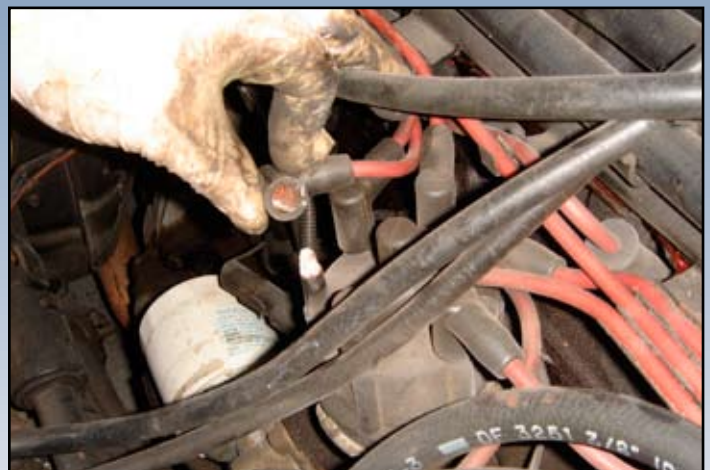
Corroded distributor cap post

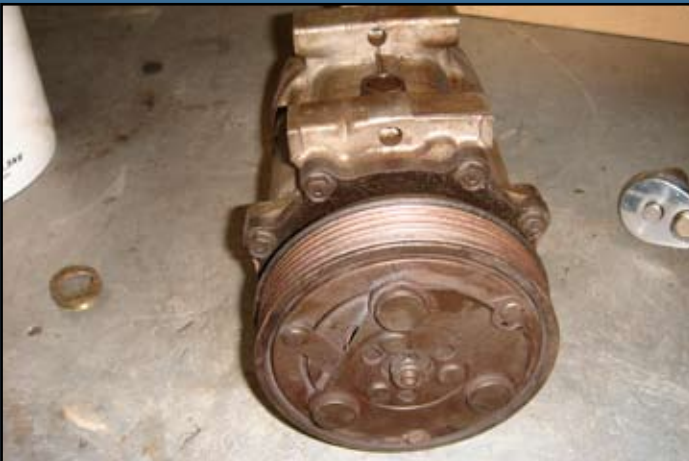
Airconditioning compressor

This 98 XJ Cherokee air conditioner compressor was very noisy. New compressors are expensive but these ones have a replaceable bearing in the clutch assembly that is not hard to change. With the right puller the clutch face assembly can be removed to access the bearing. A press is then used to remove the bearing out of the drive wheel. When re-assembling the unit the clutch needs to be shimmed to just clear the drive pulley between five and ten thou, it's a tricky repair but possible. They sound like crook power steering pumps when they die so be careful identifying its not the power steering pump.

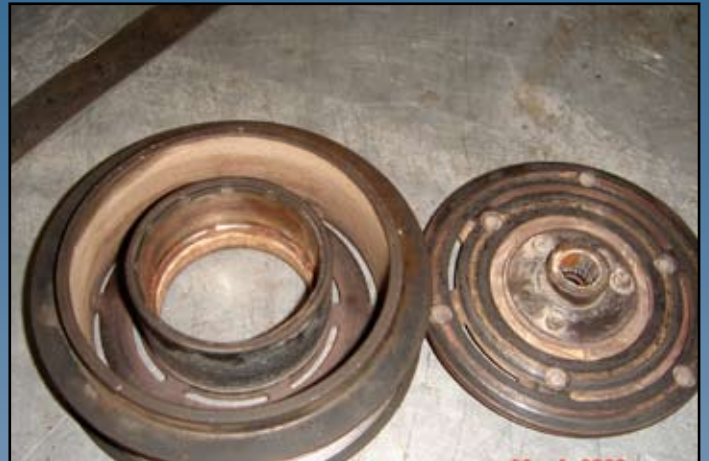
Clutch face assembly

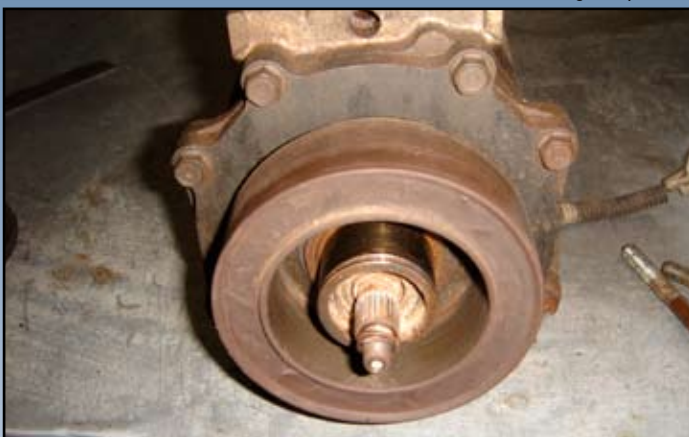
Clutch face assembly removed from the compressor

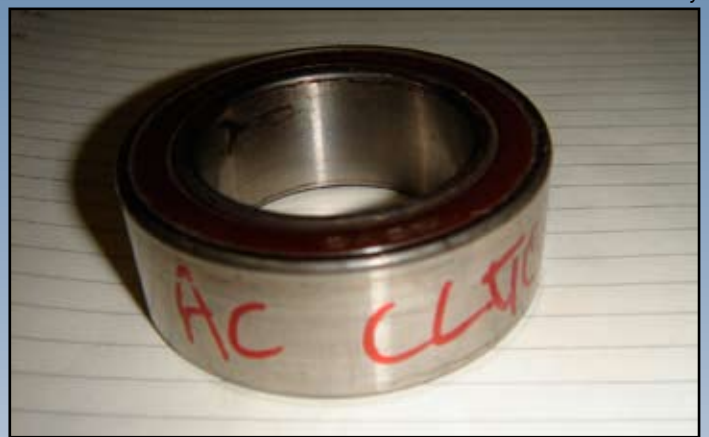
New bearing

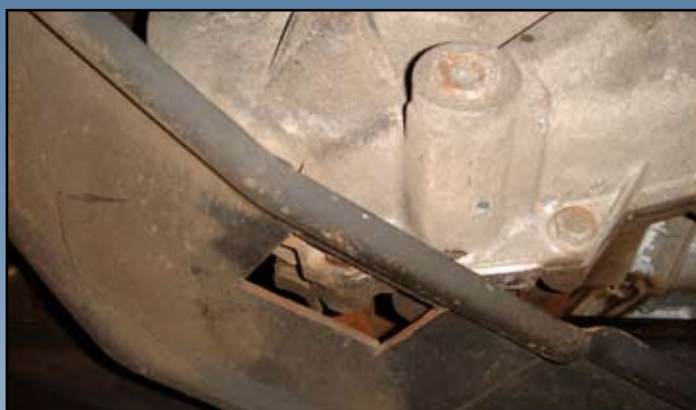
Hole cut in transfer case bash plate

This XJ arrived for a lift kit but it needed some corrective surgery before we even started! Some legend had discovered the transmission mount had collapsed – a lot. So instead of fitting a new one they have got the grinder out and hacked a hole in the bash plate to clear the bottom of the transfer case so it didn't rub anymore! MacGyver would have been proud but we weren't, so we dropped the cross member out, changed the mount and refitted it the way its meant to be.

We had to leave the hole there for now, it could do with being filled in due course.

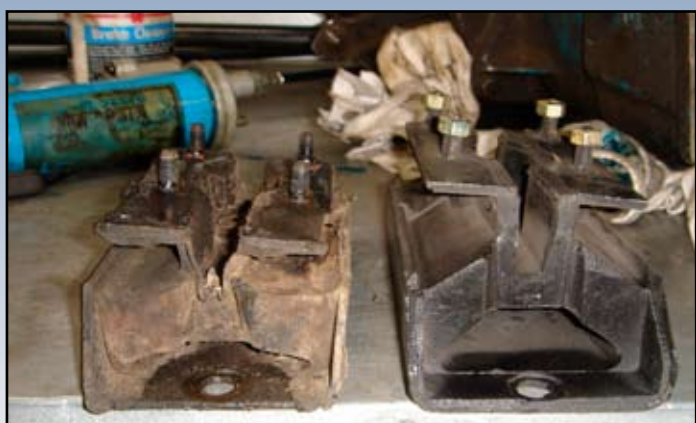
Comparing the old and new transfer case mounts

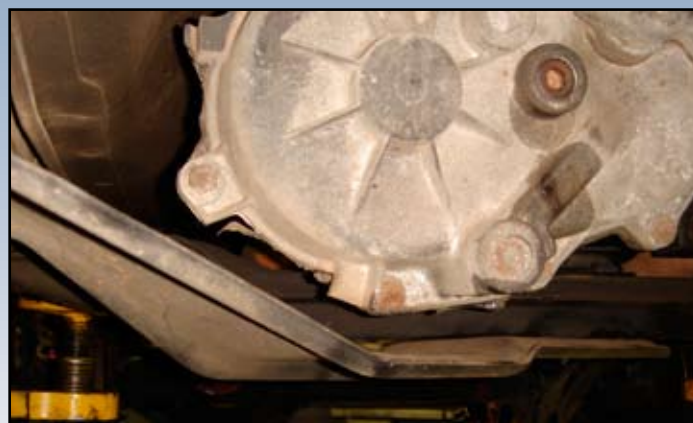
Transfer case is now clearing the bash plate with the new mount fitted
