# JEEP HOSPITAL

Each month Dr Jeep (Tony Whitehead) takes us through the trials and tribulations at his "Jeep Hospital", USA 4X4 Jeep Specialist in Melbourne, Victoria. Over 20 Jeeps are admitted weekly for servicing and suspension work through to differential, transmission and engine rebuilds. Dr Jeep explains the diagnosis, the corrective surgery and future care of these vehicles.

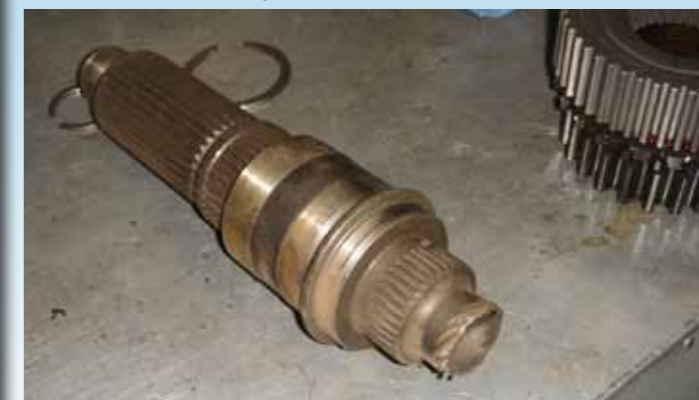
The blue spiral collar is the new drive compared to the steel spiral on the right.

The Teraflex SYE is typical of most SYEs and upgrades the speedo drive size to roughly twice the size and strength. You will need a new drive shaft as well. We use Teraflex or Tom Woods shafts and to finish the job a U-bolt style diff yoke is used.
