Each month Dr Jeep (Tony Whitehead) takes us through the trials and tribulations at his "Jeep Hospital", USA 4X4 Jeep Specialist in Melbourne, Victoria. Over 20 Jeeps are admitted weekly for servicing and suspension work through to differential, transmission and engine rebuilds. Dr Jeep explains the diagnosis, the corrective surgery and future care of these vehicles.

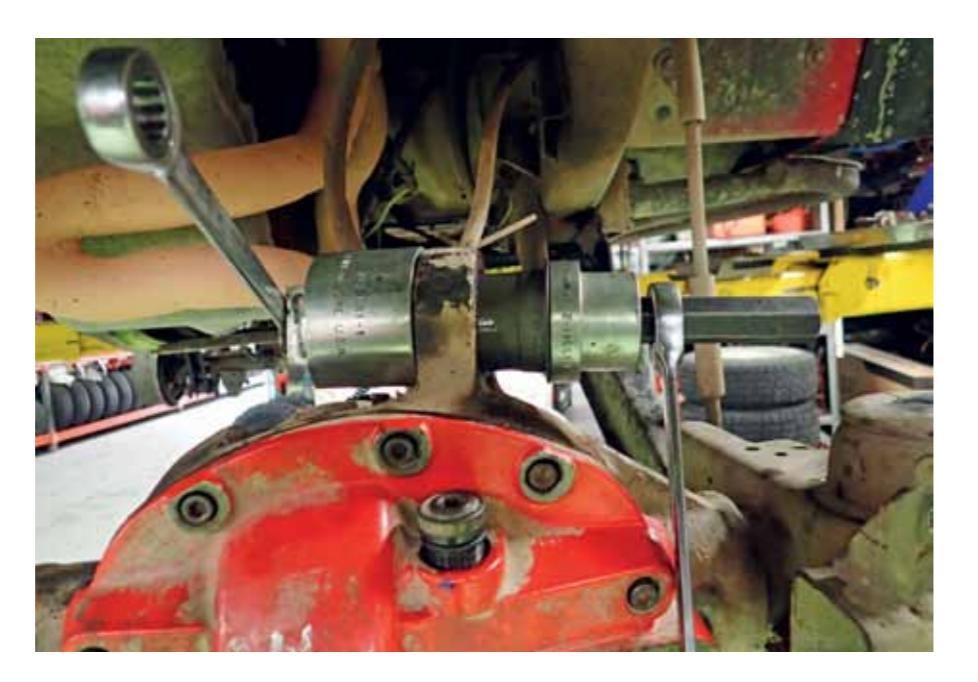
Ever wondered how those upper bushes come out of the axle housing? This is the full set up by Miller tools. You could improvise with some appropriately sized pieces of tube and a length of all thread but the right tools obviously make the job easier.

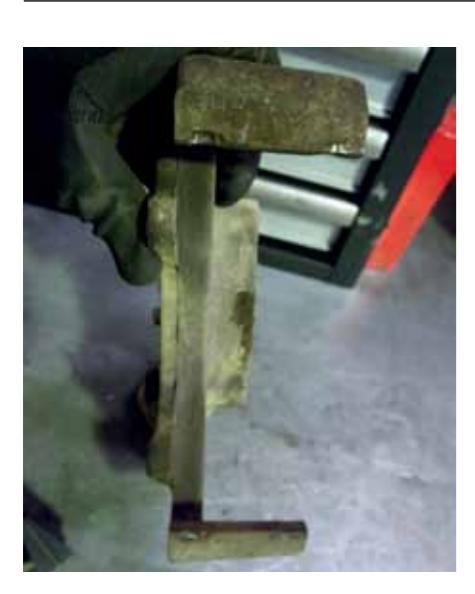
TJ/XJ/ZJ FRONT BRAKES

This is becoming more and more of an issue as these Jeeps get older. The front disc brake pads sit on these steering knuckles and wear a divot into the surface where the backing plate of the pad sits. This means the pads don't move evenly and you can get a pull to either side. The only way to repair it was to replace them with some good second hand ones. After seeing this I looked at a few old front ends I had here and they are all showing the same wear pattern, but some much worse than others. If you change a set of pads over have a look how the steering knuckle is faring.

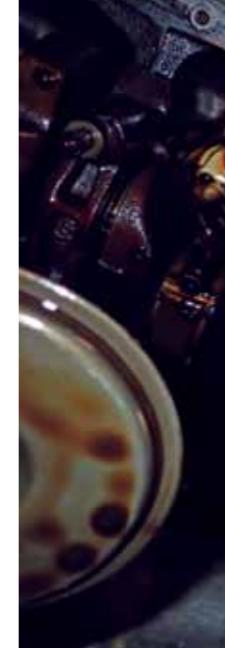
4.0L REAR MAIN SEAL

The old 4.0L Chrysler motor is renowned for three things; guzzling juice, lasting for ever and dripping oil from the rear main seal. It's not a massive job to sort out. The sump comes off and the rear main cap is removed to access the two piece rubber rear main seal. Loosen off all the main bearings to allow a pin punch to pike the old one out and new one in. We also have a set of install studs that centre the gasket on the block with dobs of grease to hold the one piece gasket in place. Then the sump can be pushed back up and bolted on after the main bearings are all torqued up. Inspect your rear main bearing condition too while you're there and take a look up the bores as well, you might find some other surprises as you inspect those two things.

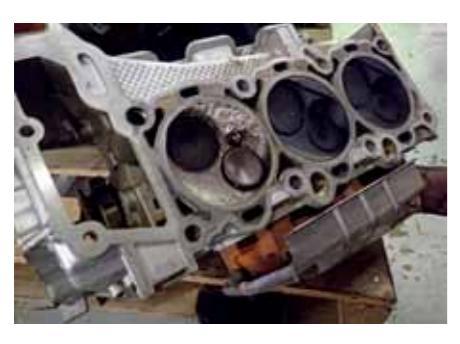
ONE HOT KJ

We ended up buying a 2003 KJ recently from the owner that had cooked the 3.7L petrol motor on the freeway. The initial problem was a leaking radiator. When it got hot on the freeway the driver refused to stop and consequently cooked the number one cylinder to the point of destruction. The motor was a total write off. We replaced the engine with a low kilometre replacement unit, a new radiator and went through the Jeep from one end to the other for a new owner to take care of.

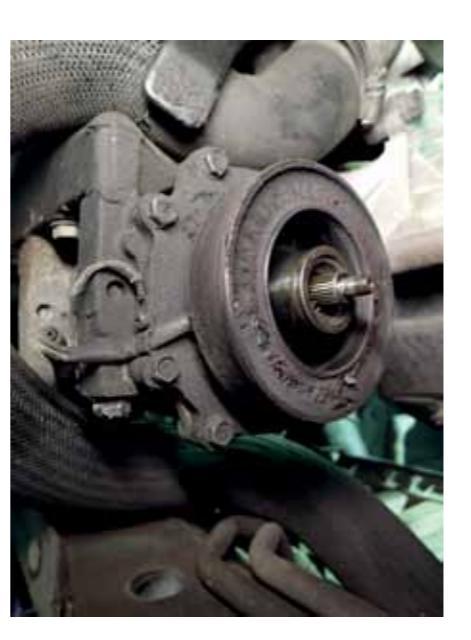
XJ A/C COMPRESSOR

While doing a service on this 99 XJ we replaced the air conditioner pulley bearing. With the clutch assembly off we found the electromagnetic coil insulation deteriorating, it won't last much longer. Lots of Jeepers seem to leave their A/C permanently on, this will shorten the service life of your compressor. Wind down your window!
