JEEP HOSPITAL

Each month Dr Jeep (Tony Whitehead) takes us through the trials and tribulations at his "Jeep Hospital", USA 4X4 Jeep Specialist in Melbourne, Victoria. Over 20 Jeeps are admitted weekly for servicing and suspension work through to differential, transmission and engine rebuilds. Dr Jeep explains the diagnosis, the corrective surgery and future care of these vehicles.

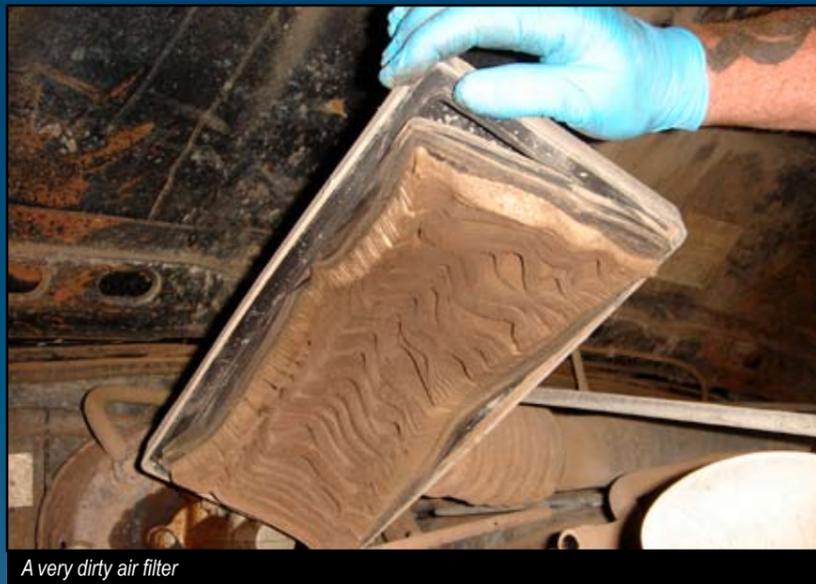
A very dirty air filter

This is a classic case of L-O-M, (lack of maintenance). The "check engine" light was illuminated on the dash of this 2005 TJ. Our scanner said one of the four casts wasn't working efficiently. No wonder, it had caved in the air filter that was caked in mud with suction. The engine would have been running rich with fuel as no air can get through such a filthy air filter. And for the last month or so it would have been giving really bad fuel economy. There are five clips on the TJ air box and it takes a minute to check the air filter. Other models are also easy to check. The damage done to the motor in a case like this will be considerable and in the long run this motor will need a rebuild much earlier than one that has been well maintained.

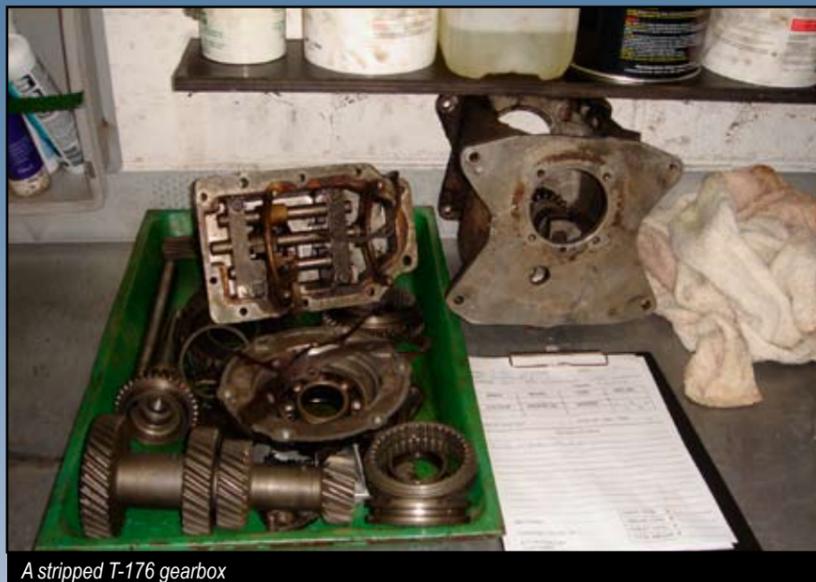
A stripped T-176 gearbox

This Tremek T-176 from a 1983 (Aussie) J10 came to us in pieces with the rear output bearing collapsed. The owner was told there were no parts available for this box. This is not the case, we can still get any parts for them and we had this transmission back in once piece in no time. The T-176 is a great 4 speed, with no over-drive, that came out in 1981 diesel CJ7 and 8s and J10s.

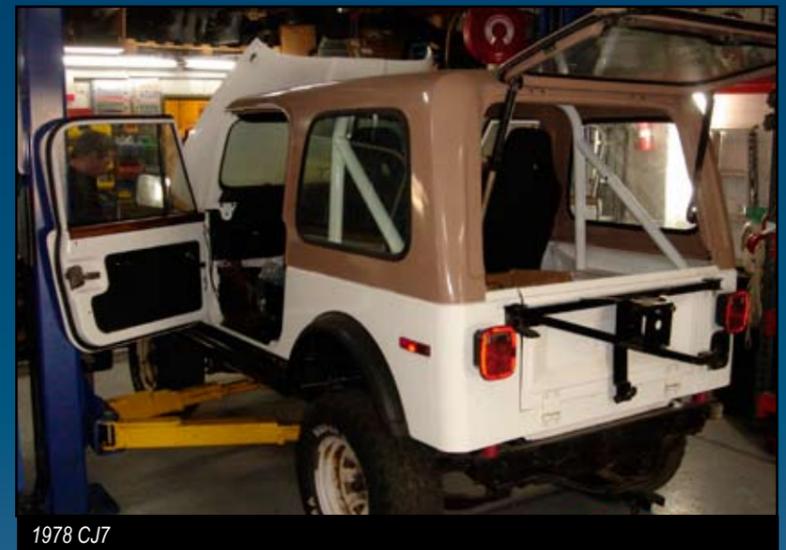
1978 CJ7

This 1978 CJ fitted with an XJ Cherokee 4.0l engine arrived at the hospital on a flat bed. The owner did a pretty good job fitting the engine and almost got it running but hit a wall in the end, so it came here. The early 4.0l runs the OBD-II computer and our scanner didn't want to talk to it. After checking over the owner's work, making sure all the sensors were wired in correctly, Travis presumed that both computers supplied were crook. We sourced a third unit and as soon as it was plugged in... presto, she ran like a gem.

Unfortunately the original computer was crook and so was the unit he bought on ebay. The CJ went home on a flat bed for the tidy up and final work.

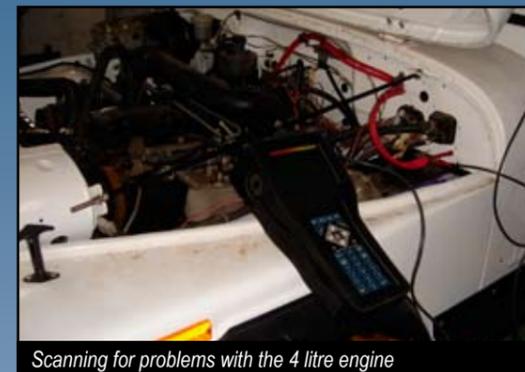
Scanning for problems with the 4 litre engine

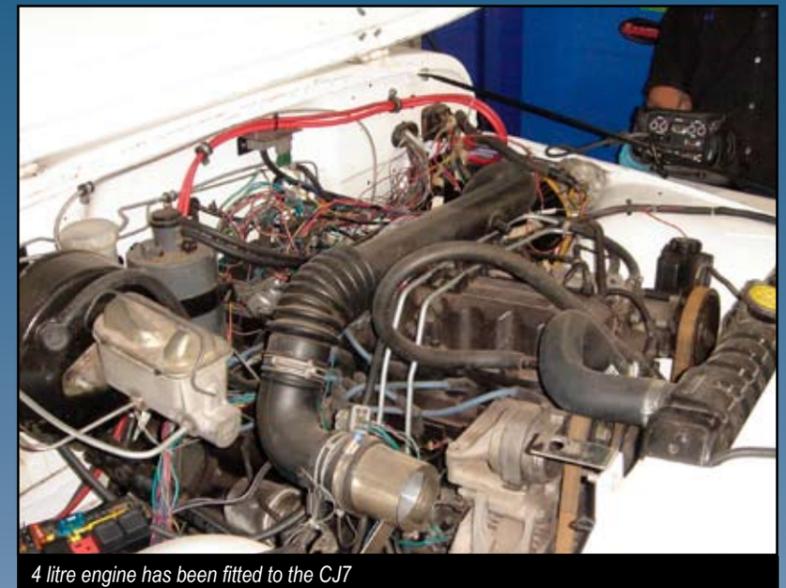
One thing Jeep has carried over from the older AMC era to the later Chrysler era is the same engine bolt pattern. This allows you to transplant the 4.0l to an older AMC Jeep that had a 232 or a 258 six cylinder engine or even the V8s including the 290/304/343/360 and 401.

4 litre engine has been fitted to the CJ7

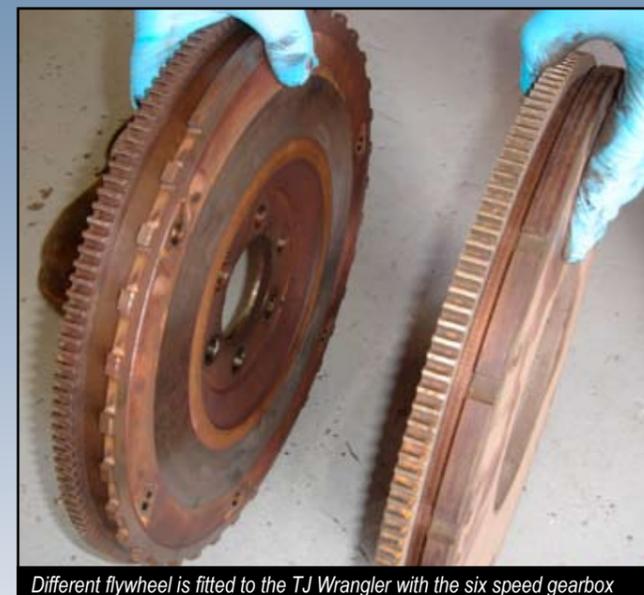
Different flywheel is fitted to the TJ Wrangler with the six speed gearbox

We had to replace a clutch in a 2005 TJ recently and discovered something new. The original TJ from late 1996 to mid 2000 had the Asian AX-15 gearbox (with the weak fifth gear assembly and 3.83:1 1st) and then came the heavier new venture NV3550 with a stronger fifth and 4:1 first gear. In late 2004 the six speed NSG370 became available and has a great first gear ratio of 4.46:1 compared to 3.83:1 for the AX and 4.01:1 for the NV. When we went to swap fly wheels over with a machined up flywheel we always have in stock for either five speed we discovered the crank position triggers much different from the two five speeds. We had to send this one out for the machine job. You should always machine the fly wheel when changing a clutch over. We also seal up the bell housings and supply a fording plug so the next bog hole this Jeep goes into won't be its last for a while. This clutch died prematurely thanks to a mud bath and the driver selecting gears while immersed in the goop.
